Errata disclaimer: This Errata applies to SLG46110 revision LT-6G.

## ISSUE 1: Long RC OSC Settling Time Functional Block Affected: RC OSC, Counter, Delay

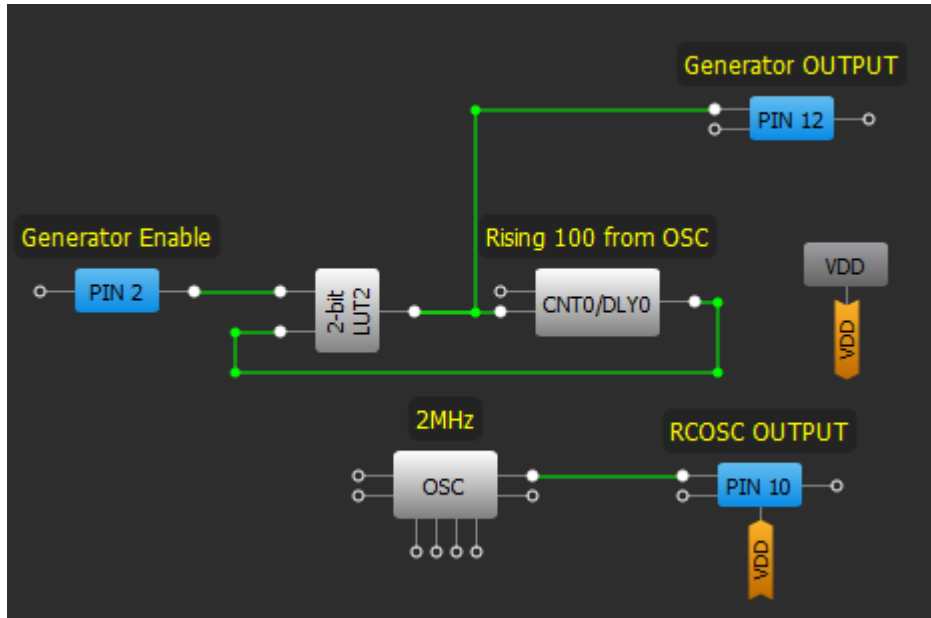
The RC OSC has a longer settling time when configured as 2 MHz with Auto Power On in the designs that have very short RC OSC disable time.

An example of such issue is in the following configuration:

The configuration shown above generates a periodical signal with a frequency defined by the Delay cell and started by a HIGH signal on PIN2. The issue becomes apparent in a longer settling time when the scheme generates short pulses (Delay is configured as a rising edge delay only). See waveform below.

- Use the “Force power on” RC OSC power control option to make the RC OSC operate at all times.

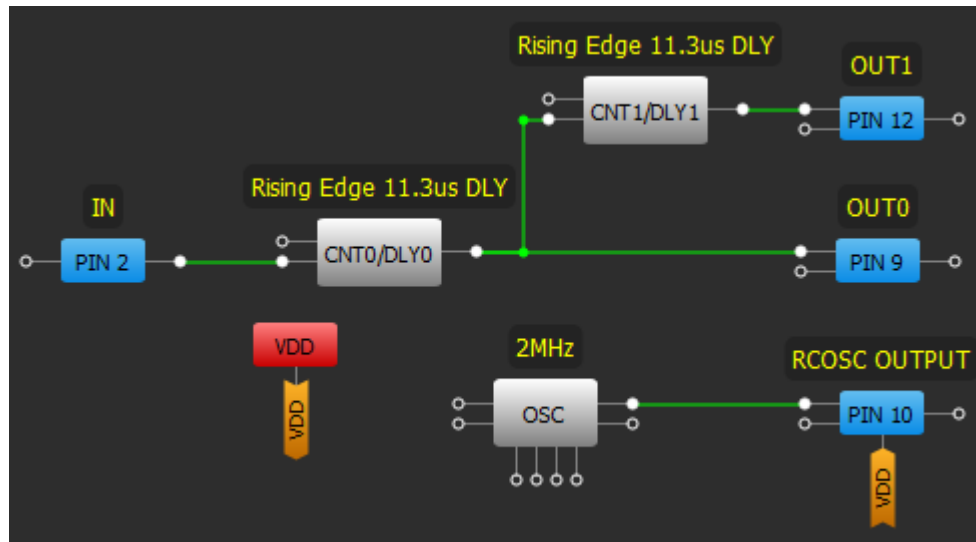
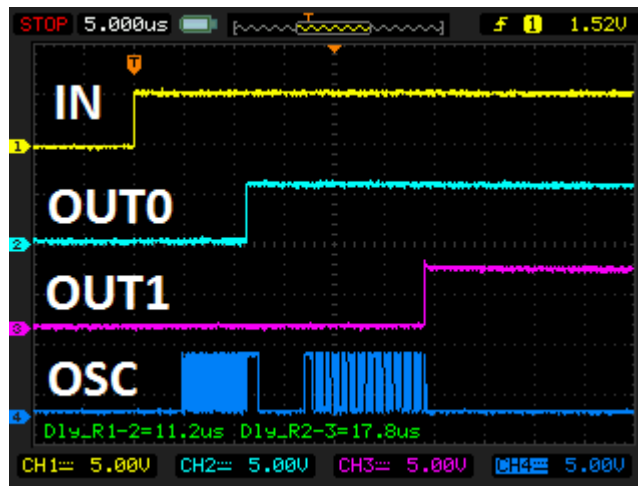
The same situation occur while using two connected delays (all edge detect types except for a pair “Rising edge DLY – Falling edge DLY”).

In the following example, Delay0 and Delay1 are configured in the same way. However, Delay1 time is 17.8us instead of expected 11.3us (Delay0 time).

- In first case use block with longer propagation time.

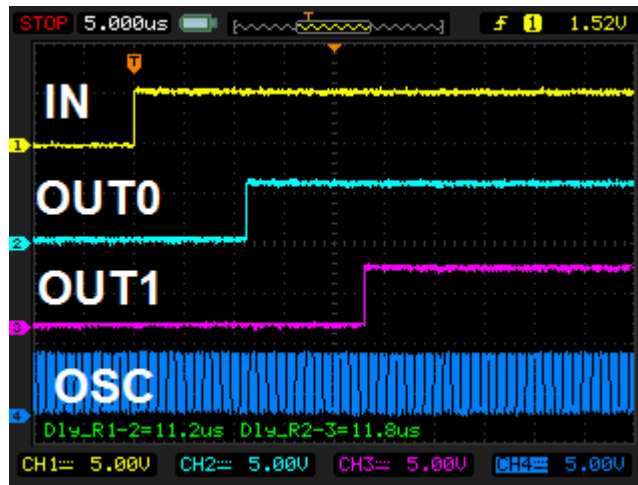
If there are some inner blocks which use RC OSC at the moment or RC OSC is forced power on when such error appears, RC OSC will be operational and delay value will be proper.

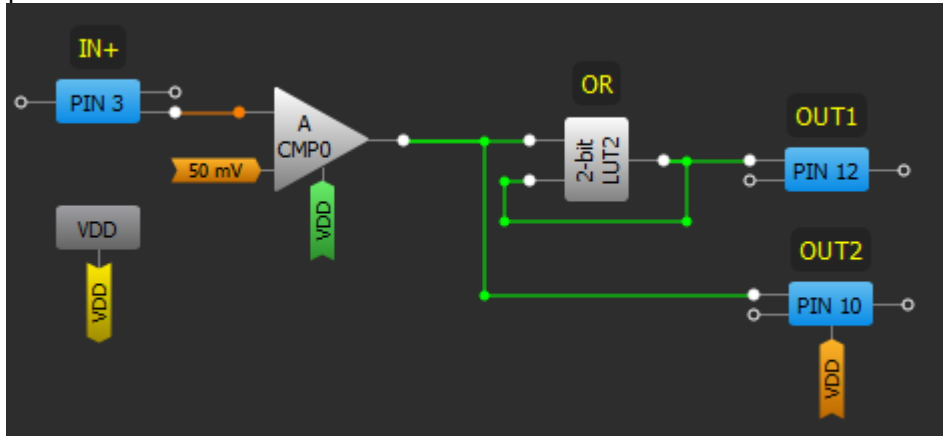
In some cases, ACMP may have short high-level glitches on its output (even if IN+ voltage is less than IN- voltage) after GreenPAK chip being powered up. Such cases may appear when using ACMP with Low Bandwidth mode enabled and Power Up is connected directly to the VDD.

Conditions of glitches appearing are determined by IN- voltage, VDD value and VDD Ramp (see example tables below).

In order to detect such glitches, scheme with additional LUT was used. This LUT detects high level on ACMP output and stays high until chip powers down.

ACMP IN+ is connected to the Ground.

- Use POR block, connected to the ACMP's Power Up pin. However, in this case ACMP will start working with low level output and will be able to go high only after POR goes high + ACMP power on time.

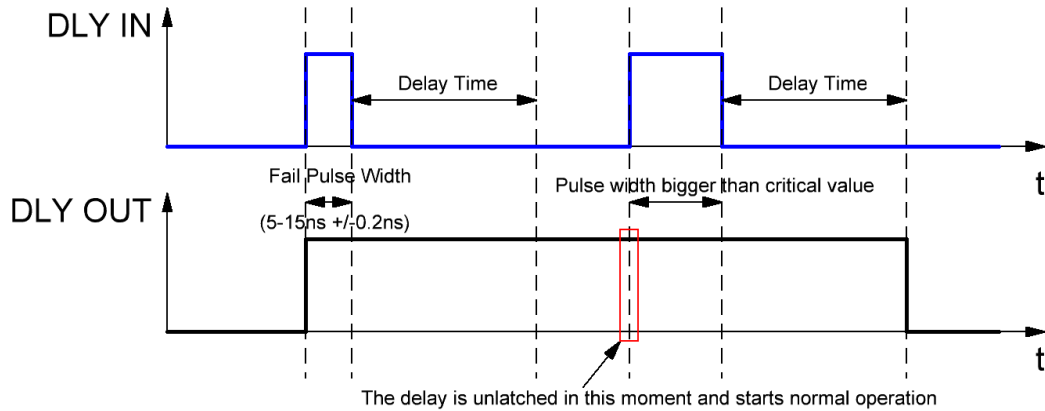
## Falling Edge Delay

The delay output could be latched despite the input change when a short pulse is input. For example, if the delay cell is configured as a falling edge delay, the short pulse (see NOTE) appears on its input the delay cell output will switch from LOW to HIGH but may not switch from HIGH to LOW even after the delay time has passed.

NOTE: The pulse width varies from chip to chip and with different VDD voltage. It is in range of 5-15ns and in the window +/-0.2ns, so it should be very precise for issue happen.

- Use P DLY/FILTER block configured as a both edge delay or FILTER.

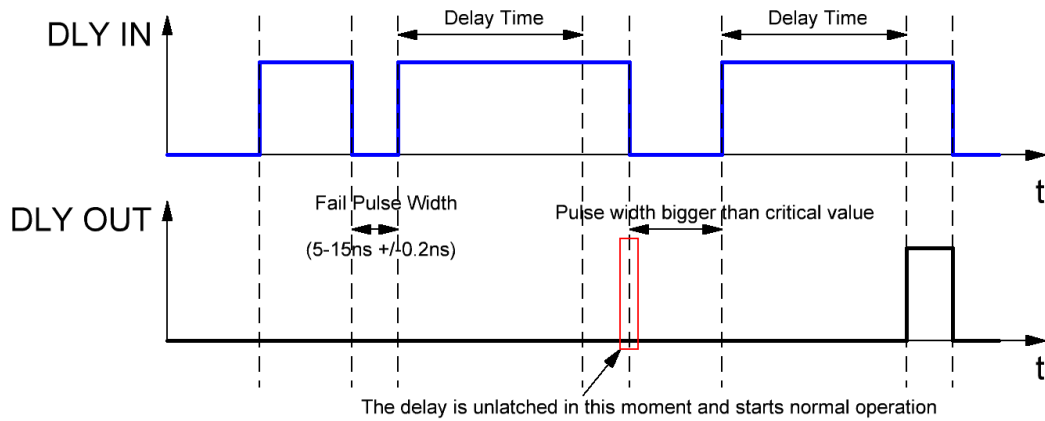
## Rising Edge Delay

Also, note that both edge delays does not have such issue.

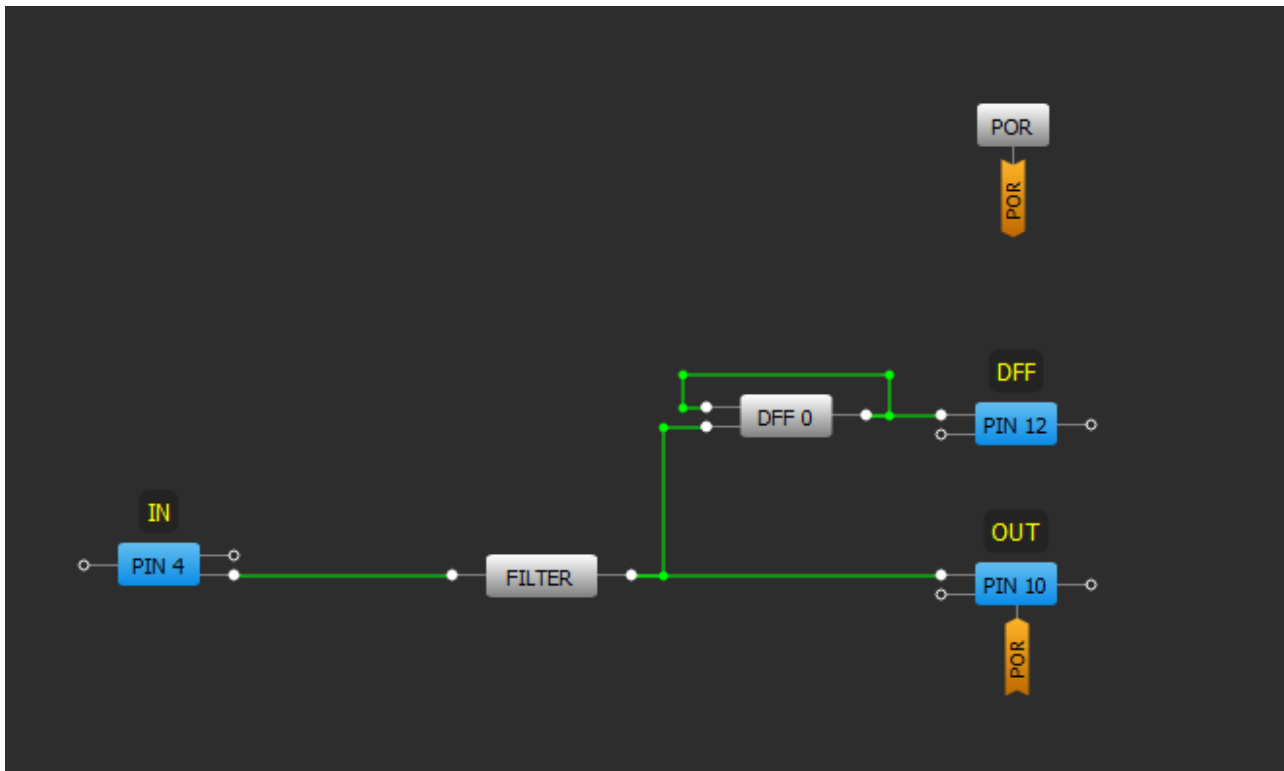
If clock type high frequency input comes in, the FILTER cell may not filter out it. There are several factors like input frequency, duty cycle and LOW duration in such signal that may lead to its passing through FILTER block.

Channel 1 (yellow/top line) – PIN#4 (IN)  
Channel 2 (light blue/2nd line) – PIN#10 (OUT)  
Channel 3 (magenta /3rd line) – PIN#12 (DFF)

Currently there is no workaround for this issue. Filter block is good at filtering short spontaneous glitches. It is intended to be used in series connection before the delay cell to avoid its latching (see issue #5).

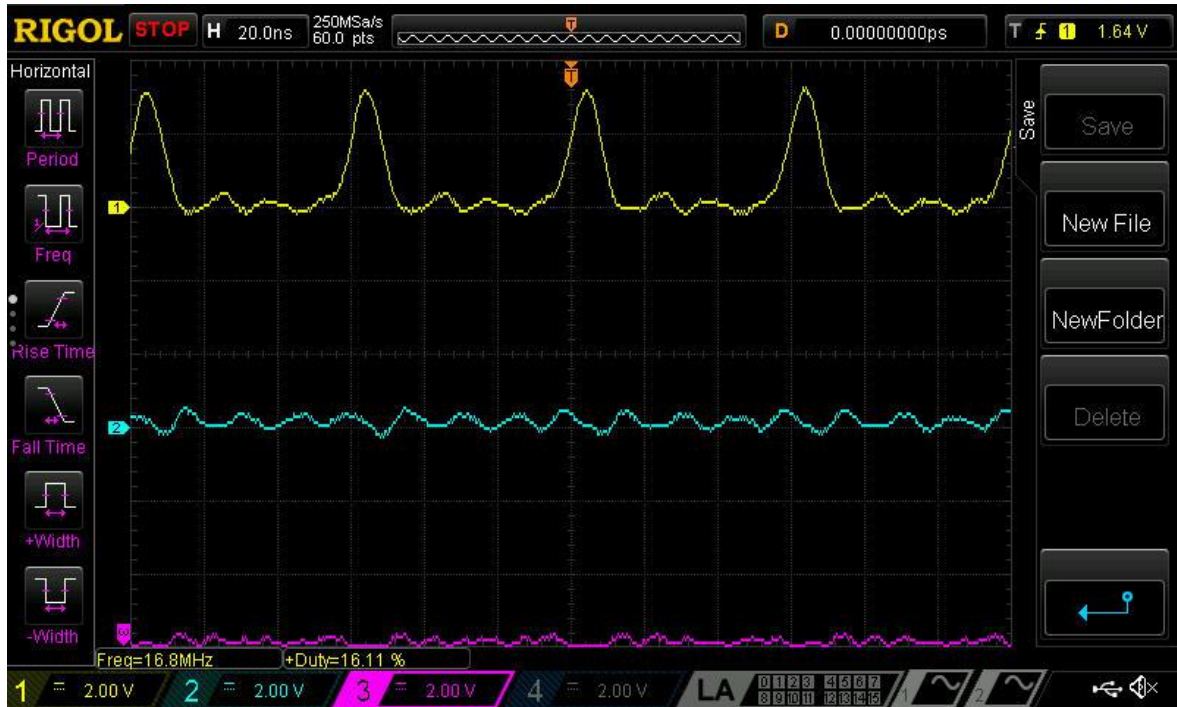
1. Period is 60ns. Pulse width is 10ns DC=16.7% (Correct functionality)

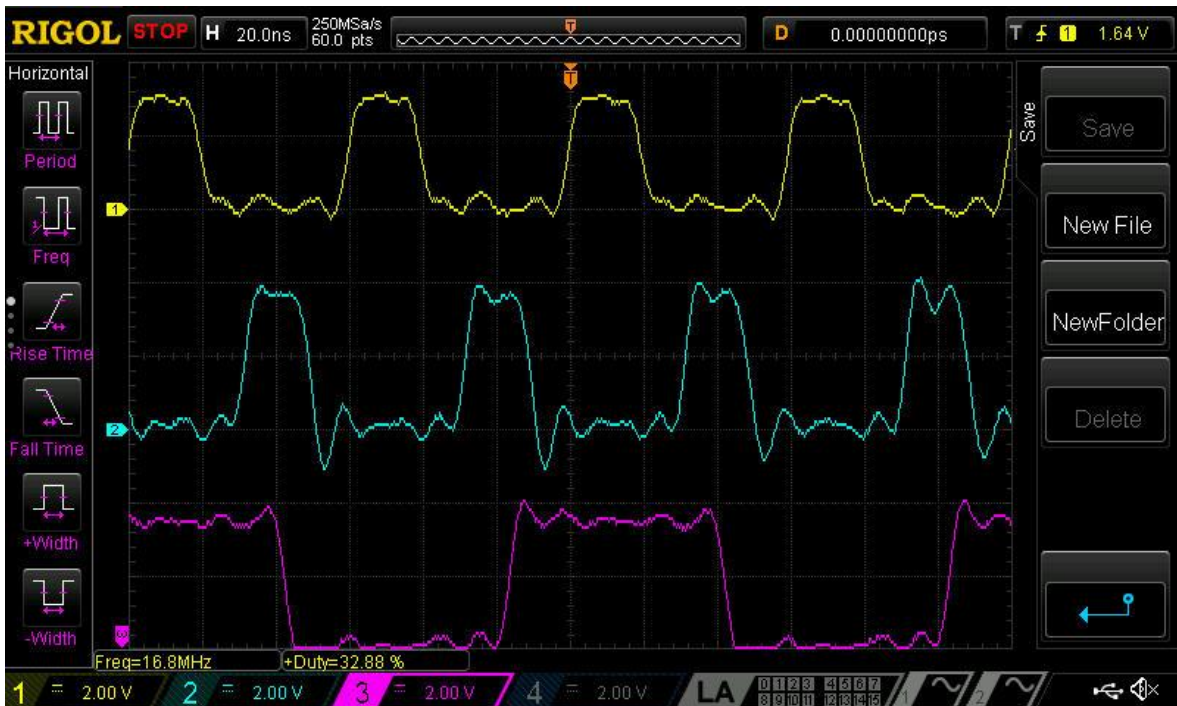
2. Period is 60ns. Pulse width is 20ns DC = 33.3% (Incorrect functionality)

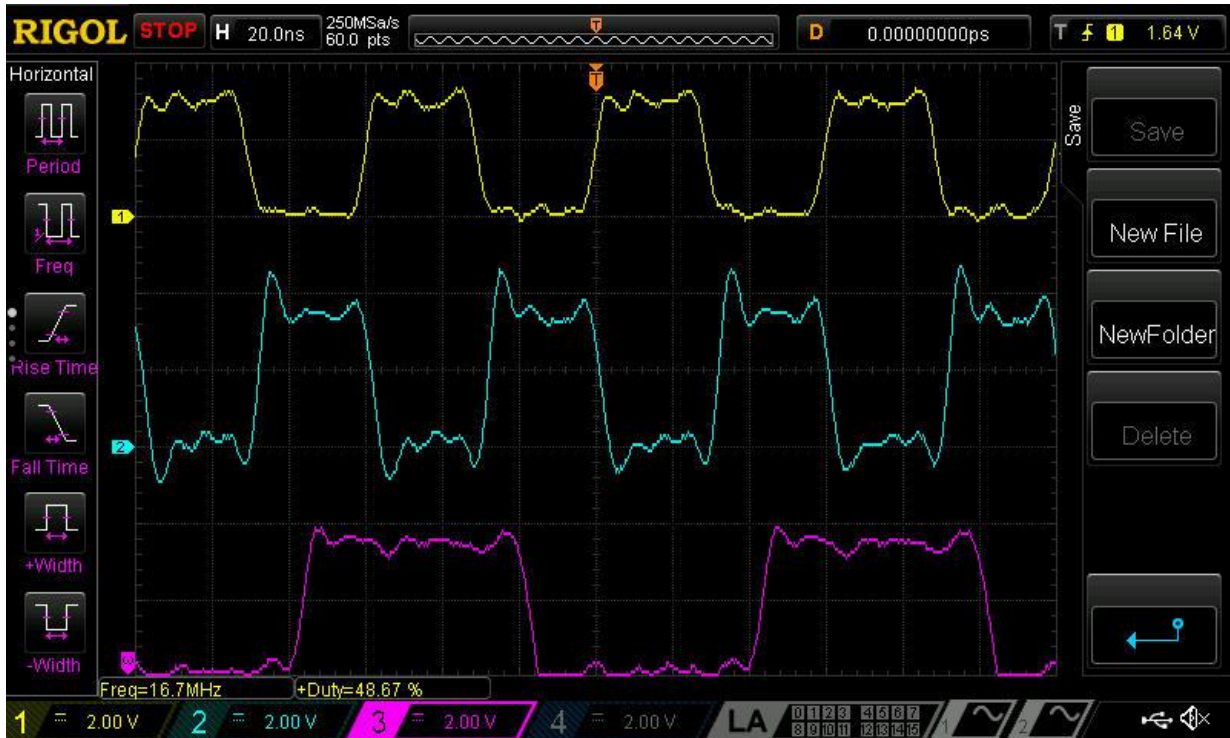
3. Period is 60ns. Pulse width is 30ns DC=50% (Incorrect functionality)

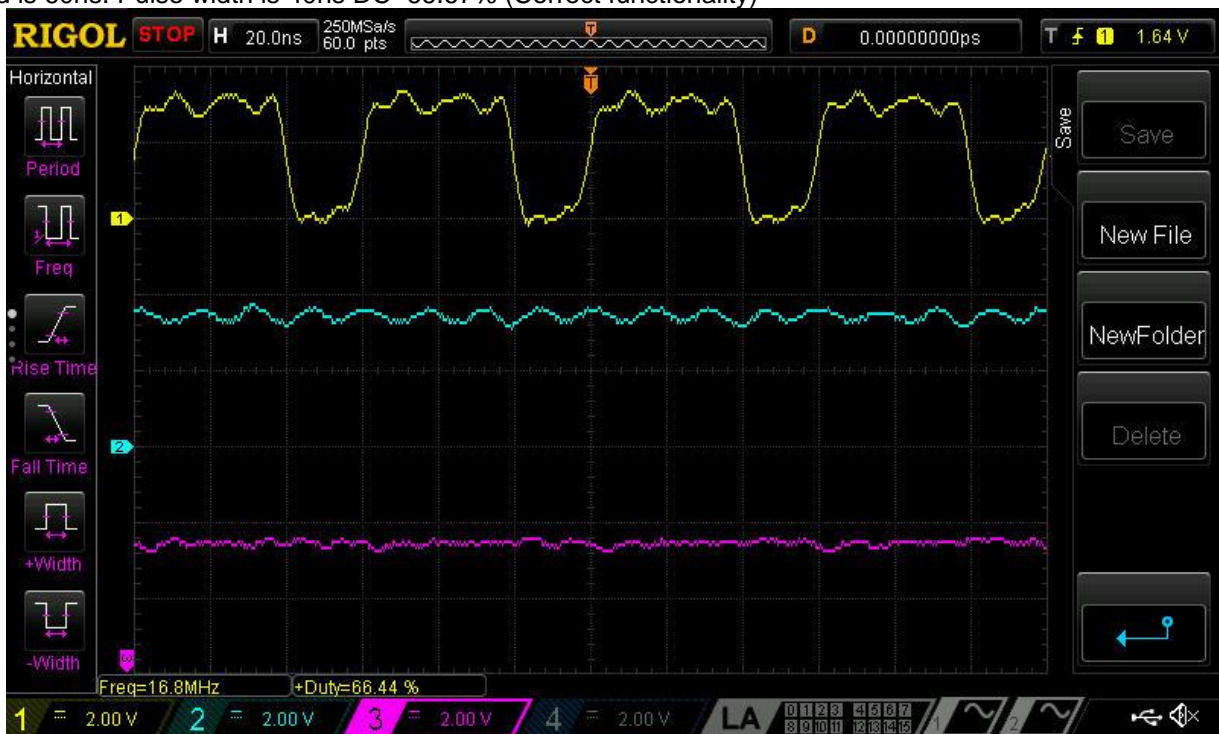
4. Period is 60ns. Pulse width is 40ns DC=66.67% (Correct functionality)
